RESEARCH AND DEVELOPMENT TECHNICAL REPORT
CORADCOM- 77-2640-F

**DRILL PARAMETER STUDY
(MM&T PROJECT 2769779)**

JACK QUINTANA
TOM WEISMULLER
HUGHES AIRCRAFT CO.
FULLERTON, CA 92634

JANUARY 1979
FINAL REPORT FOR PERIOD 2 JANUARY 1977 - 30 OCTOBER 1978

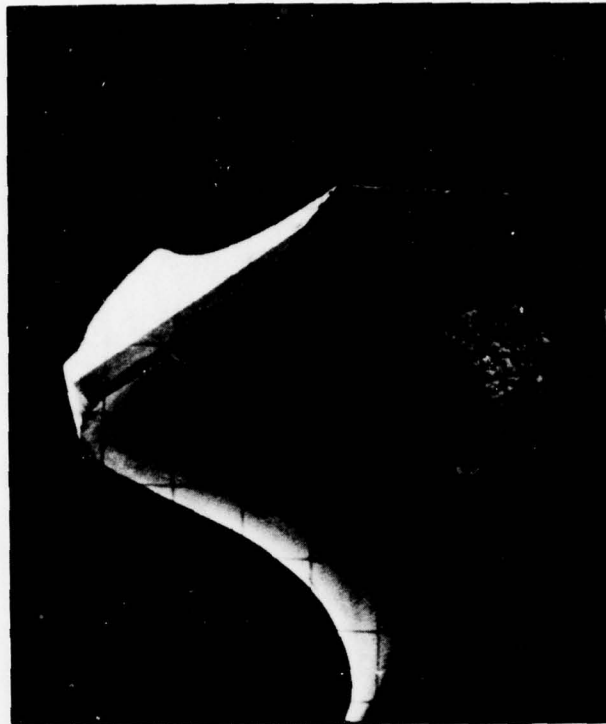
Figure B2. Standard Carbide Drill - After 4200 Hits

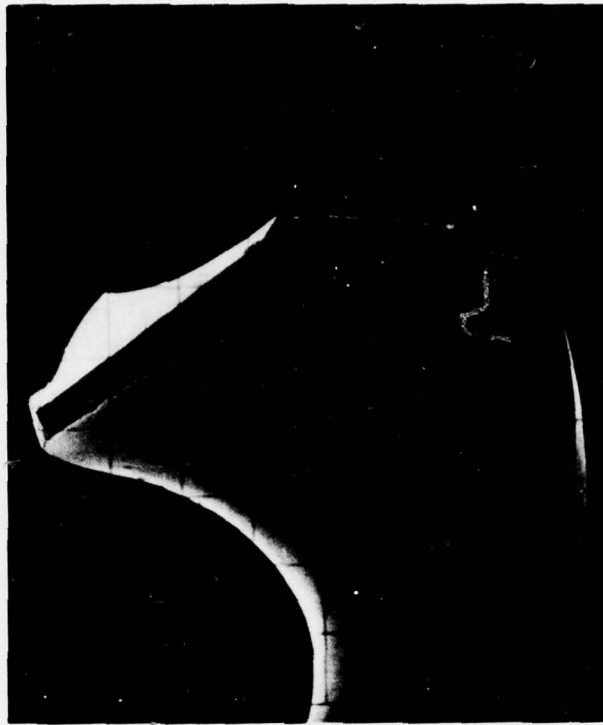
Figure B14. Micro Grade Drill - 118° Point, 12° Relief - After 4200 Hits
